Public Toilet Facilities Strategy Adopted by Council 27 June 2011

Introduction

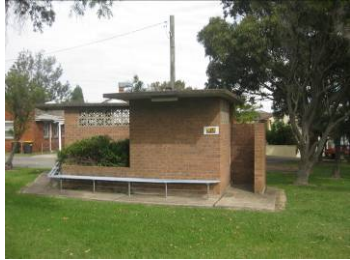
<p>656 Pacific Hwy; Belmont Cullen Park</p>	Brick	2P	M, F	2 per week
	<p>Accessibility: Poor - no accessible toilet, no accessible path of travel, or accessible car park provided.</p> <p>Lighting: Limited natural lighting</p> <p>Signage: Provided</p> <p>CPTED: Design of toilets would not meet CPTED principles</p> <p>Users: Limited use mainly at night</p> <p>Proximity to: Park, main road, hotel, yacht club</p> <p>Other: Difficult to access from main road. Reports of anti social behaviour on site.</p>			
	<p>Recommendation: Close and demolish facility</p>

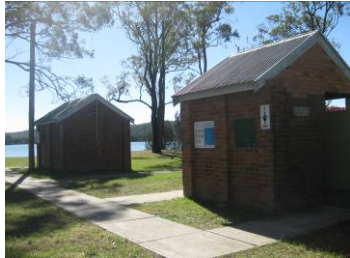
<p>1a Blackall Ave; Blackalls Park</p> <p>Blackalls Park</p>	Brick x 2	2 G	M, F	7 per week
	<p>Accessibility: No accessible toilet provided, an accessible path of travel provided but does not link up with car park, no accessible car park allocated.</p> <p>Lighting: Natural lighting is satisfactory</p> <p>Signage: Provided</p> <p>CPTED: Location could promote anti-social behaviour</p> <p>Users: Walkers, picnic and lake users – high use area</p> <p>Proximity to: Park, lake and picnic facilities</p> <p>Other: Park used regularly by those having lunch and exercising.</p> <p>Recommendation: Design and construct new facility compliant with AS 1428 and CPTED principles. Update accessible path of travel to join car park and provide an accessible car park.</p>

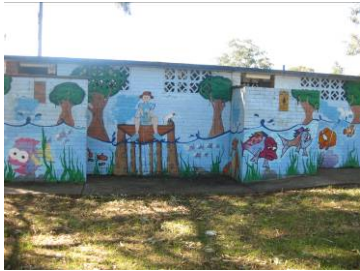
<p>Middle Point Rd; Bolton Point Bolton Point Park</p>	Brick	3P	M, F	7 per week
	<p>Accessibility: No accessible toilet, path of travel or car park provided.</p> <p>Lighting: Limited natural lighting</p> <p>Signage: Provided</p> <p>CPTED: Evidence of anti-social behaviour</p> <p>Users: Mainly park users and walkers</p> <p>Proximity to: Bolton Point Hall, park, picnic area</p> <p>Other: Toilets are dirty and dark. Community hall toilets currently being upgraded to include accessible toilet facility.</p>			
	<p>Recommendation:</p> <p>Full CPTED assessment be completed then review.</p>

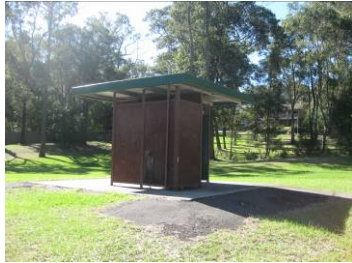
<p>119 Bay Rd; Bolton Point (off Prospect Ave)</p>	Modular	3F	NI	5 per week
	<p>Accessibility: No accessible toilet, path of travel or car park provided.</p> <p>Lighting: Natural lighting is satisfactory</p> <p>Signage: No signage provided</p> <p>CPTED: Location could promote anti social behaviour at night.</p> <p>Users: Mainly walkers and lake users</p> <p>Proximity to: Park, lake and baths</p> <p>Other:</p> <p>Recommendation: Retain - continue existing cleaning and maintenance schedule. Provide signage</p>

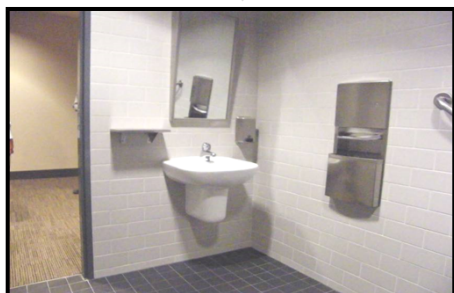
A good example of the installation of a washbasin and other fittings, including a shelf as required by Table F2.4 of the BCA, note that tilt mirrors are not a requirement of AS1428.1.
