Cemeteries Conservation Management Plan

VOLUME 2 – INDIVIDUAL CEMETERIES

SEPTEMBER 2021

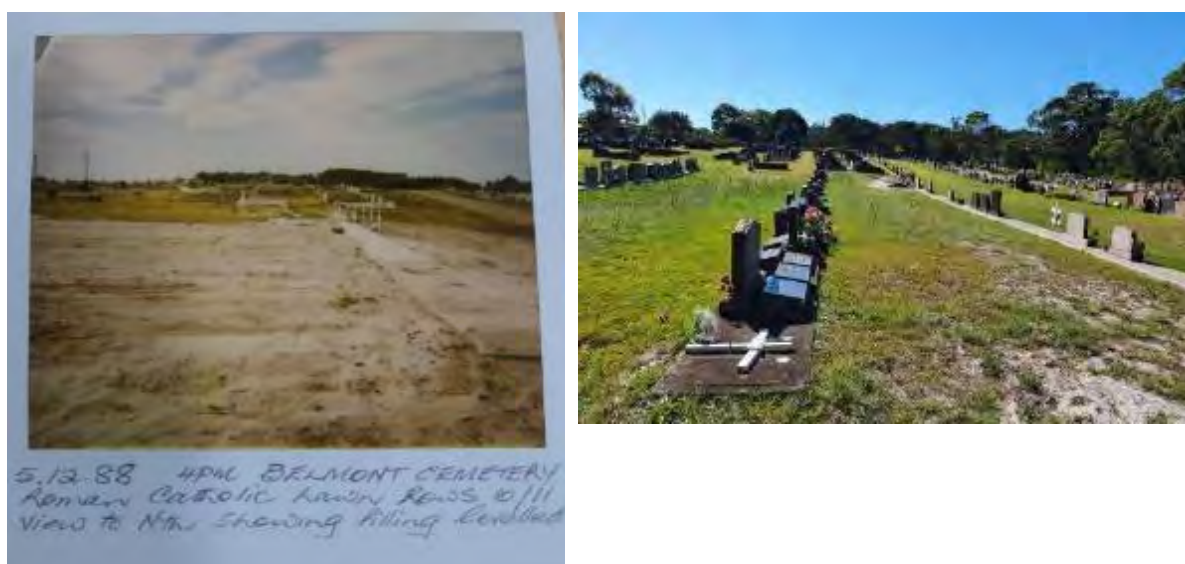
Figure 7 Belmont Cemetery Roman Catholic - Rows 10 and 11 -1988 and present day

Photographs taken during the installation of the beams during cemetery works in 1988 shows the significant change that has occurred since that time.

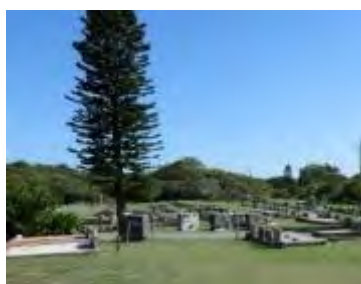
Analysis: The modest gardens suit the nature of the cemetery. The long-term retention of mature trees is important. The success of native species in the sandy soil encourages further plantings of similar types.

Mature Norfolk Island pine.

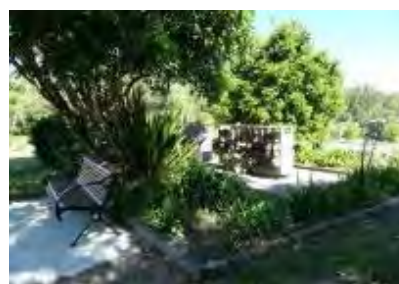
Garden planting associated with columbaria.

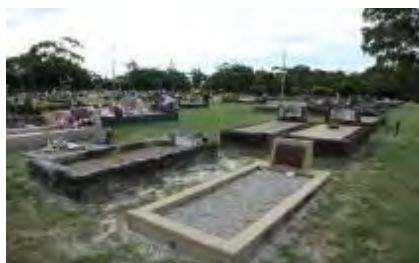
Analysis: The cemetery has a layout that is consistent with other cemeteries investigated as part of this project.

Note: graves are facing south

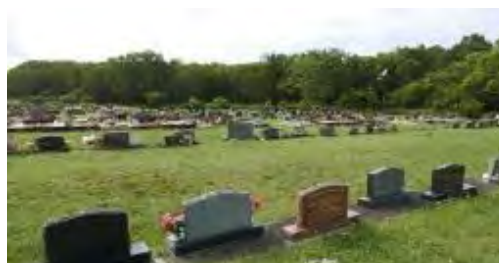
Modern beam layout

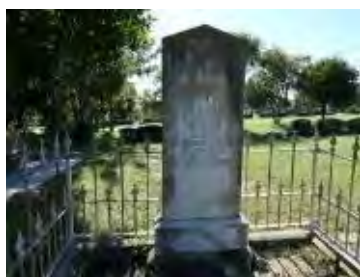
Analysis: Representative of the transition of headstone styles from the late nineteenth century to the present day. In terms of management, the earliest stele headstone and cast-iron surrounds are most vulnerable to damage resulting from their age, style and type of material. That risk of damage decreases with the lower profile mid-late twentieth century headstones with the beam style headstone by nature most resilient to damage.

Late nineteenth to early twentieth century headstone.

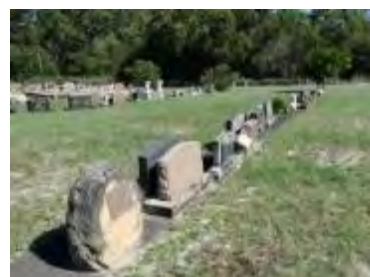
Late twentieth century beam headstones.

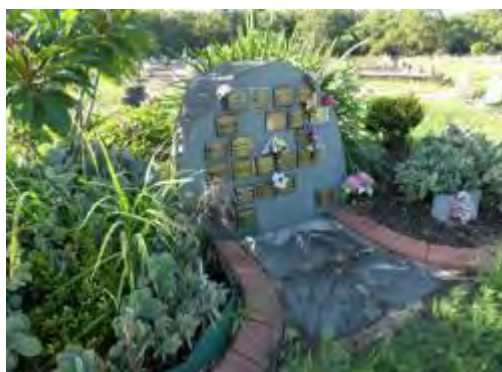
Memorial boulder

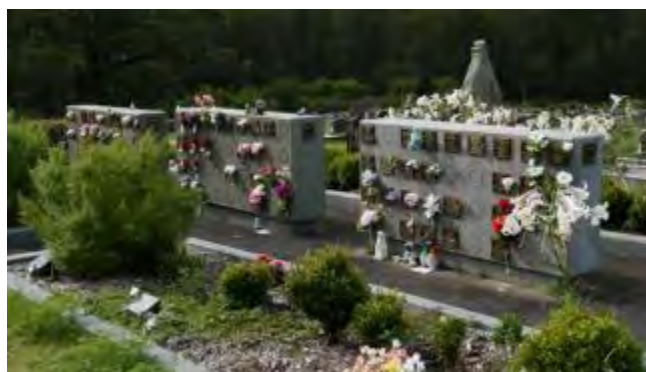
Analysis: The memorial walls and columbaria have been introduced to the cemetery since 2000. Their style is utilitarian and not conducive to the low-key appearance of the headstones.

Columbaria

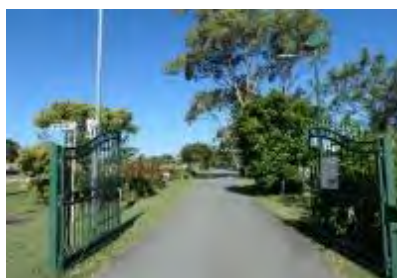
Description: Belmont Cemetery has an aluminium entrance gate that replicates an earlier cast iron style. The gates stand-alone without a complimentary fence. The gates are locked each night and re-opened in the morning by a member of the 'Friends of Belmont Cemetery' who lives close by. The fence on the western side is of treated pine and wire. Sections of the southern and eastern fence are of steel and wire fence, likely intended to stop access via 4WD or motorbikes, however during the inspection a motorbike rider was observed riding along the rows.

Analysis: The gates and fences overall appear adequate to their task; however, one section was noted as providing access for motorbikes.

Entrance gate

Unmarked burials	Identify unmarked burials to prevent inadvertent damage or disturbance.		Consider a GPR study, if required, to identify unmarked graves and identify areas for potential burial space.
Gates and fences	Retention of gates and fences	Low	Regular maintenance. An access point on the southern western corner of the cemetery used by motor bikes should be closed.

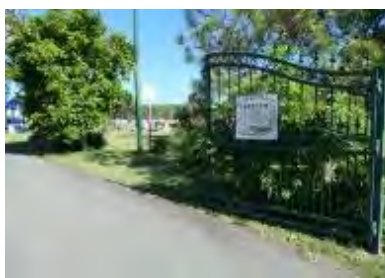
Entrance gate with sign

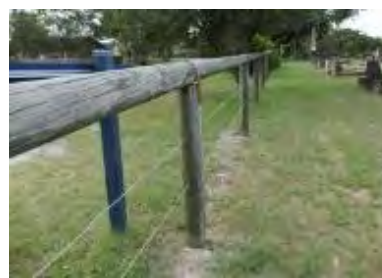
Fencing parallel to Green Street

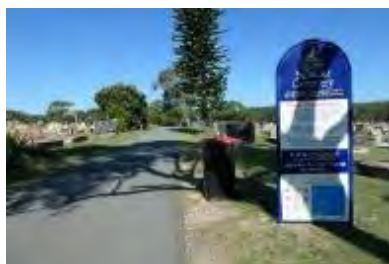
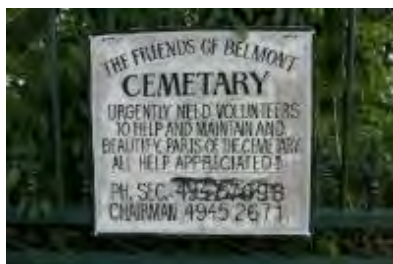
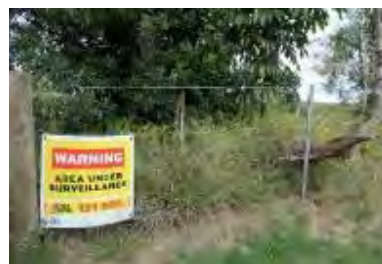
Description: The large Council erected entrance sign is consistent with all others for Lake Macquarie Cemeteries. A sign on the front gate, possibly placed by the 'Friends of Belmont Cemetery' is in poor condition and has a significant spelling error.

The front gate sign would be best removed. A more comprehensive sign that contains information such as: a plan of the cemetery layout, a brief history, information on graves of note and contact details for the 'Friends of Belmont Cemetery' (if they are agreeable) is warranted.

Element	Requirement	Priority	Recommendation
Signage	Maintain existing signage and provide additional signage.	Moderate	Remove sign on front gate and replace with a more comprehensive sign near entrance that includes a cemetery plan and brief historical detail on the cemetery, identifies graves of interest and acknowledges unmarked burials. Provide additional denomination/ row # signage at end of each row.
Heritage interpretation	Promotion as a source of historical and family information	High	Develop and install accurate, informative, engaging heritage interpretation sign/s.
Environmental factors	Fire and storms	High	Maintenance plans to include removal of hazardous trees and undergrowth, grass regularly mown in high-risk seasons.
'Friends of'	Engage community groups	Moderate	Encourage groups to advance heritage research on interments. Assist in grounds and memorial maintenance working under <i>National Trust Guidelines for Cemetery Conservation</i> .

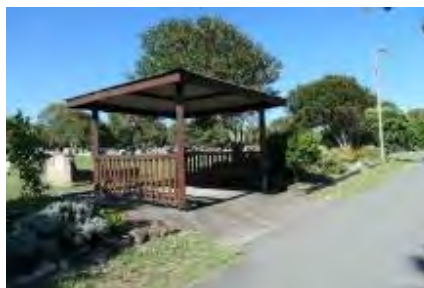
Analysis: The infrastructure is adequate and appropriate

Shelter with flood light visible

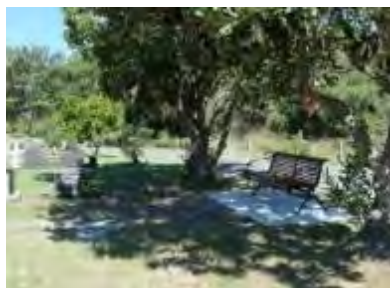
Seating

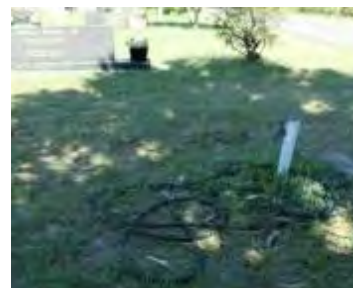
Water

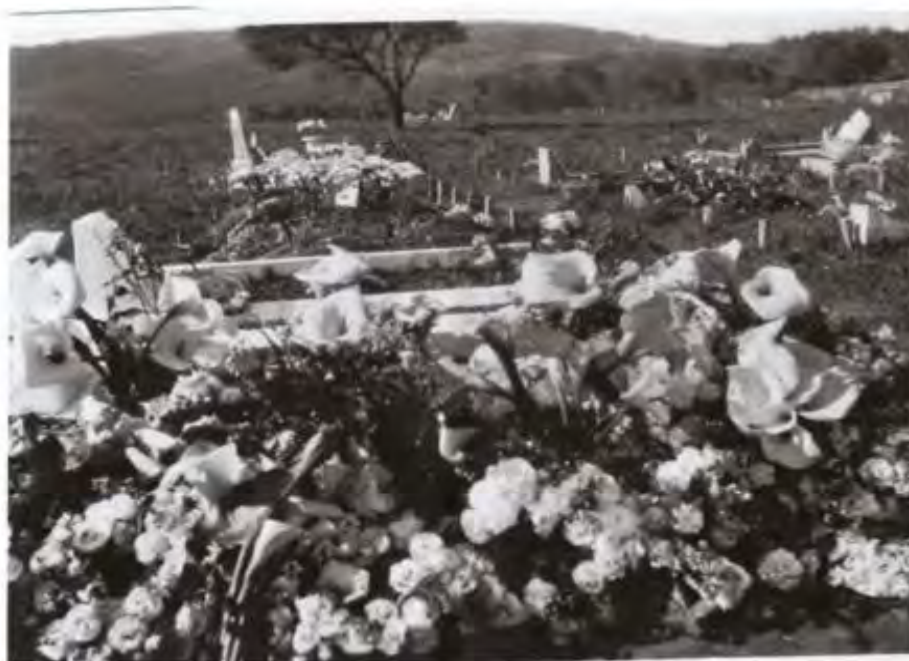
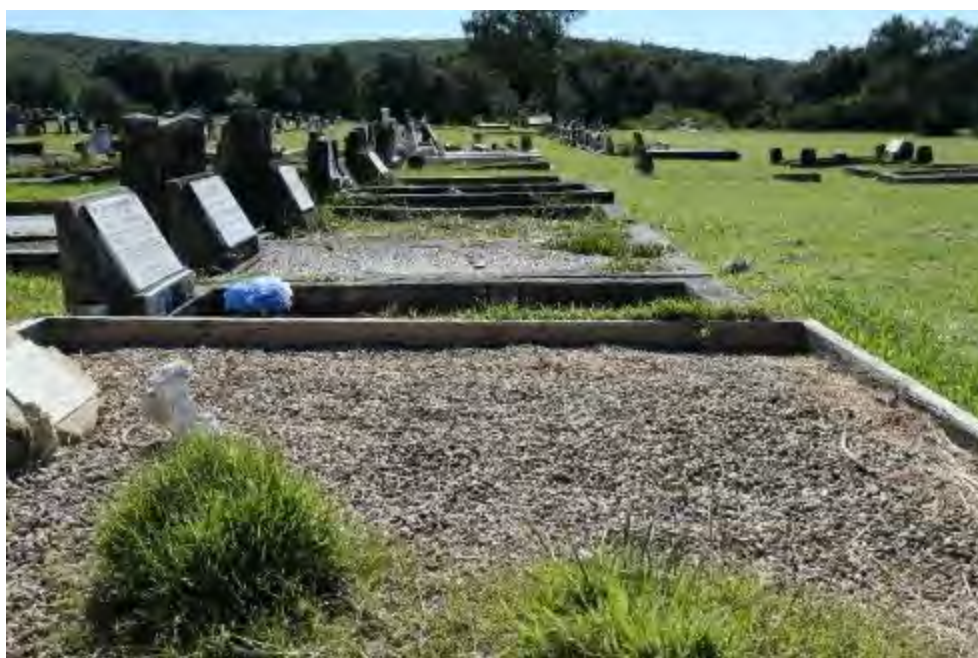
Plate 1 The grave of Ethel Campbell 1934 (Courtesy C House) and in 2021 (author).

Plate 1 shows the condition of the cemetery in 1934 (with an image from the same location in 2021). The early image appears to show the area overgrown with graves in a poor state and few substantial headstones.

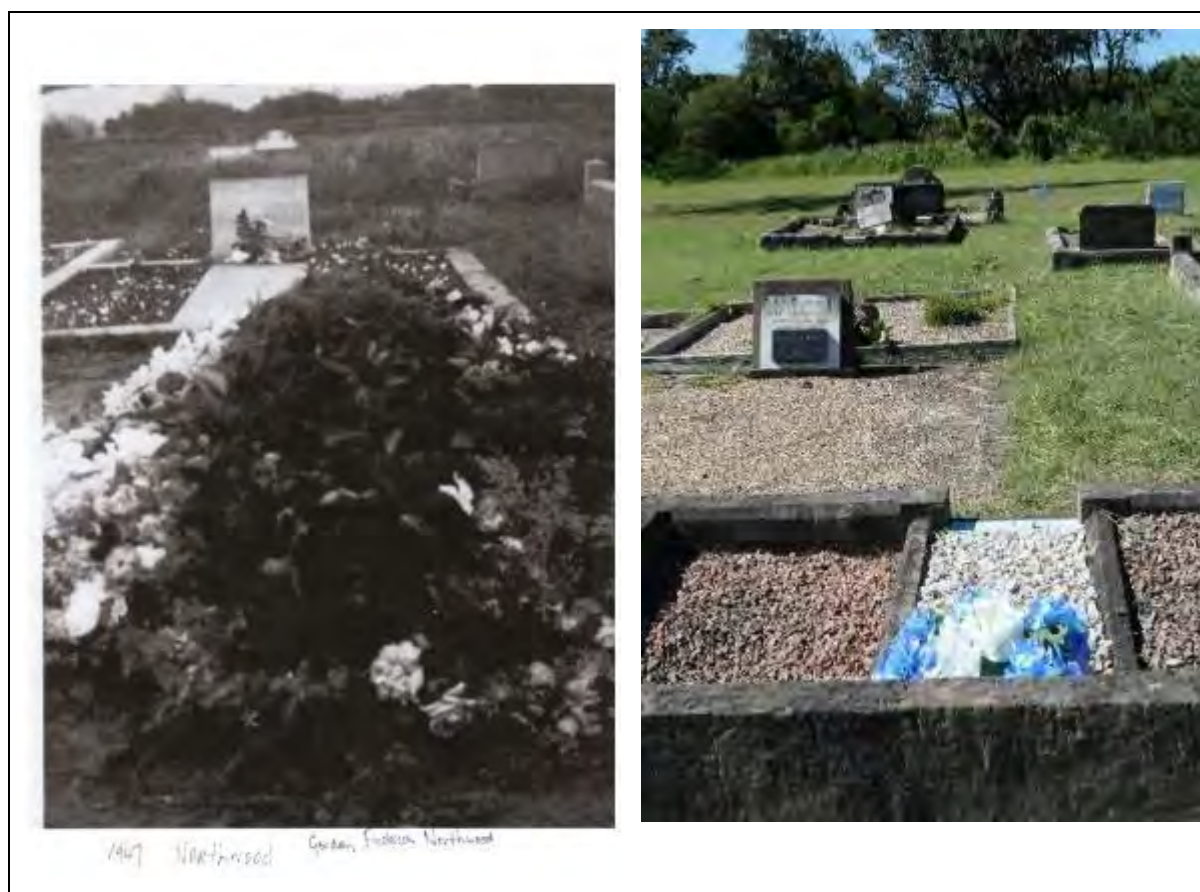
Plate 2 The grave of Gordon Frederick Northwood 1947 (Courtesy C House) and in 2021 (author).

Plate 2 shows the cemetery at that time. The cemetery remains in an overgrown state. A post and rail fence and sand dunes are visible in the background.

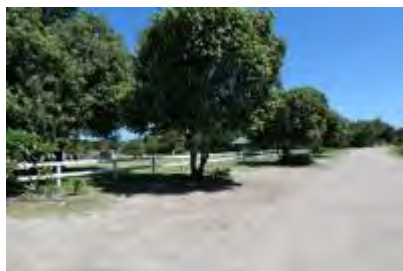
Analysis: The modest gardens suit the nature of the cemetery. The long-term retention of the mature trees is important to maintaining the cemetery's attractive appearance.

Looking south - boundary fence

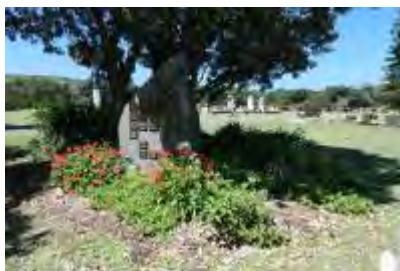
Garden and memorial boulder

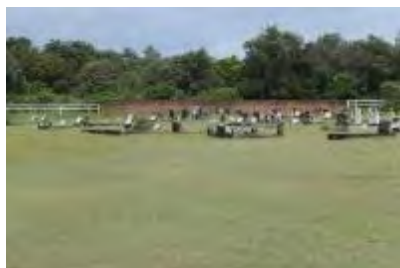
Spacious appearance

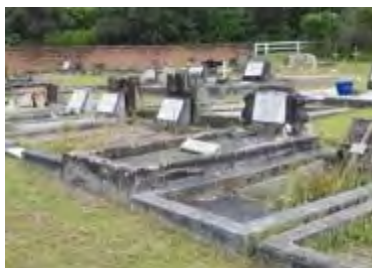
Layout in older section

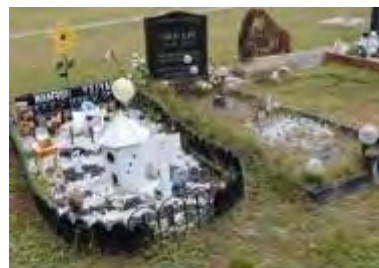
Beam section showing additional decoration

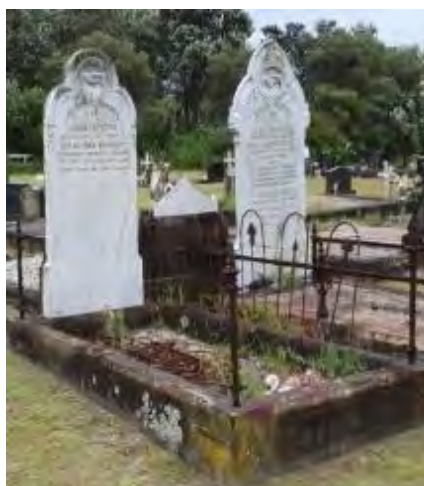
Analysis: The headstones and associated features, reflect the development of the Cemetery from its role in providing a last resting place for a tight knit mining community to providing an outlet for individual expression in remembering the deceased.

Tall stele headstones

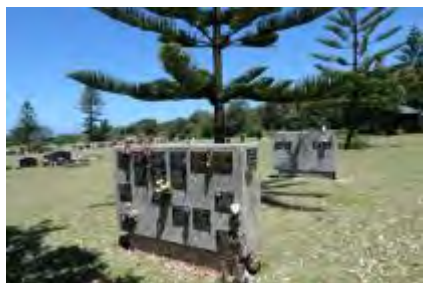
Analysis: The memorial wall and columbaria are consistent with modern burial practices and ensure that the cemetery remains operational.

Columbaria

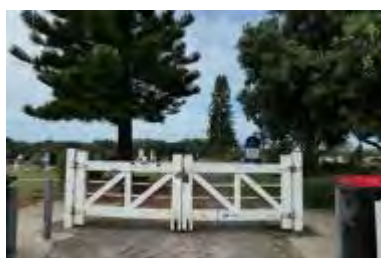
Analysis: The simple sturdy gates and fences are appropriate to the cemetery and reflect the style of the original post and rail fences.

Entrance gate

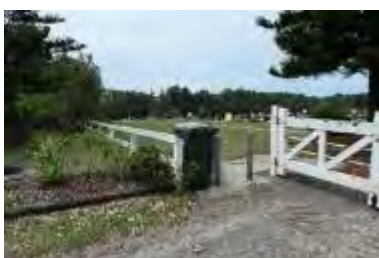
Pedestrian entrance

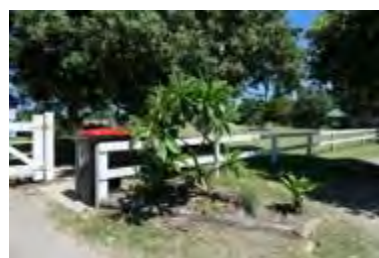
Fence

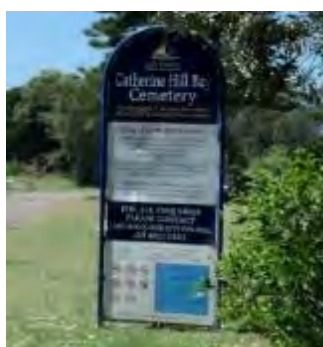
Analysis: The Council sign is consistent to all cemeteries. It would be useful to have both ends of the rows marked.

Generic entrance sign

Element	Requirement	Priority	Recommendation
Signage	Maintain existing signage and provide additional signage.	High	Install a cemetery plan sign. Provide additional denomination/row # signage at end of each row as required.
Heritage interpretation	Promotion as a source of historical and family information	Moderate	Develop and install accurate, informative, engaging signs heritage interpretation sign/s.
Environmental factors	Fire and storms	High	Maintenance plans to include removal of hazardous trees and undergrowth. Grass regularly mown in high-risk seasons.
'Friends of'	Engage community groups	Moderate	Encourage groups to advance heritage research on interments. Assist in grounds and memorial maintenance working under National Trust (NSW) (2009) <i>Guidelines for Cemetery Conservation</i> . Investigate engaging Landcare group to assist with management of coastal vegetation.

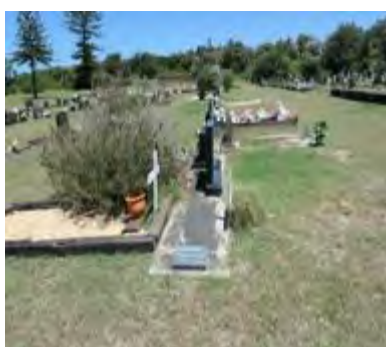
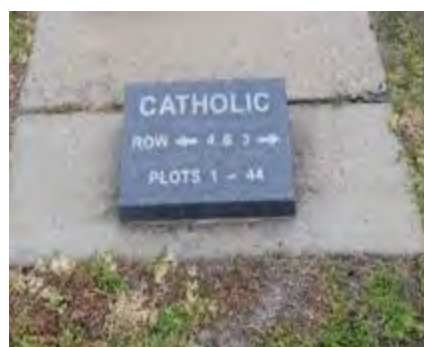
Row markers

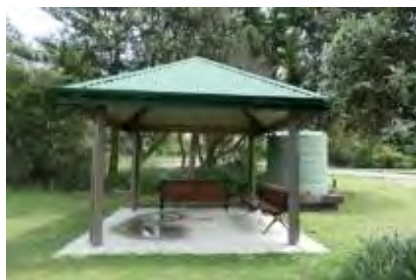
Analysis: Adequate

Shelter shed

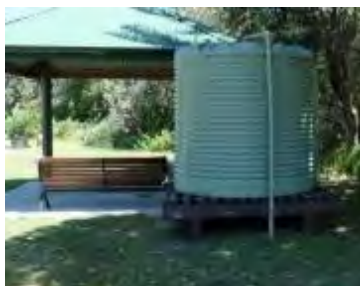
Water tank

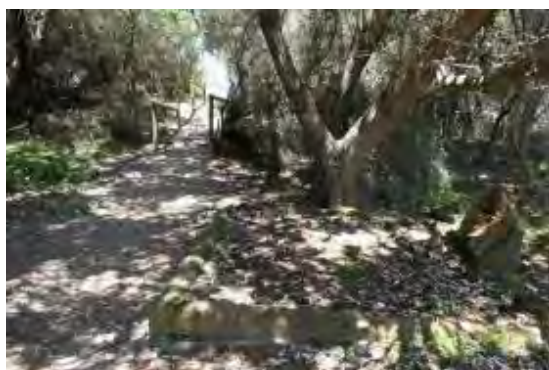
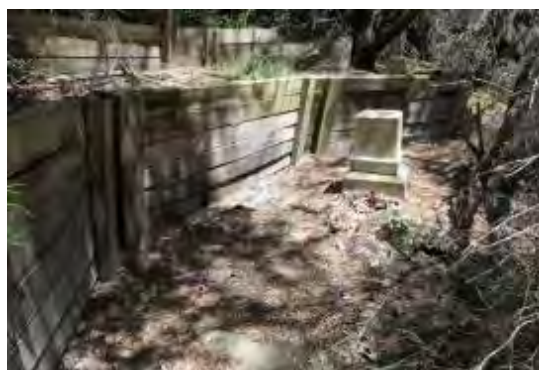
Plate 5 Primitive Methodist burials near the dunes. Plate 6 Condition of retaining wall adjacent graves.

The first group comprises six known burials in the 'Primitive Methodist' (north east) portion of the cemetery dating from the earliest burials in 1896, through to 1911. The graves are in reasonable condition though the area is overgrown and unkempt. Adjoining a beach walkway, a timber retaining wall, in poor repair, currently prevents inundation by sand.

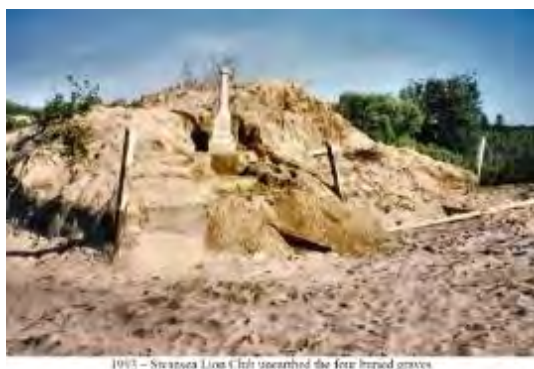
The second group of burials are in the original Roman Catholic portion. Four known headstones are visible approximately 100 metres north-east of the main cemetery in an area of native vegetation, these headstones record burials dating from 1900 to 1909. An 1891 map, annotated in 1953, possibly to inform the dispute over use of the land by National Minerals, has a faint line marked as 'top of bank' and likely marks the location of the burials. In the 1990s only the top portion of the Tobin family grave was visible, the remainder buried in a large sand dune. A Swansea Lions Club project to excavate and uncover the Tobin grave revealed three additional graves (Plate 7).

Plate 7 Tobin headstone unearthed (courtesy V. Williamson 2021)

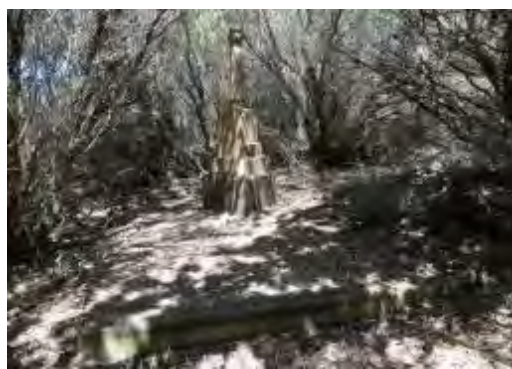
The headstones now rest on a dune stabilised by a mature coastal tea tree forest. One of the graves, a simple tablet with no inscription visible, is covered by vegetation. The headstones are in reasonable repair and appear to benefit from the protection afforded by the surrounding vegetation (Plate 8).

Plate 8 Tobin headstone.

Element	Requirement	Priority	Recommendation
Views and vistas	Retention of views and vistas both within and external to cemetery	High	Maintain coastal vegetation boundary.
Landscape, vegetation, gardens and plantings	Maintain landscaping and plantings.	High	Undertake weeding, mowing and regular maintenance. Remove dead trees, dead branches and invasive weeds on eastern boundary. New plantings to be native endemic species.
Headstones and grave furniture	Preservation in accordance with best practice	Moderate	Source funding for conservation works on older headstones. All works in accordance with National Trust (NSW) (2009) <i>Guidelines for Cemetery Conservation</i> .
Significant graves	Ensure retention of significant graves and headstones.	High	Source funding to undertake conservation works. <ul style="list-style-type: none">• Provide recognition of the conchologist, Robert Logan Cherry.• Remove vegetation impacting early Catherine Hill Bay Cemetery dune burials and repair the retention wall near group 2.

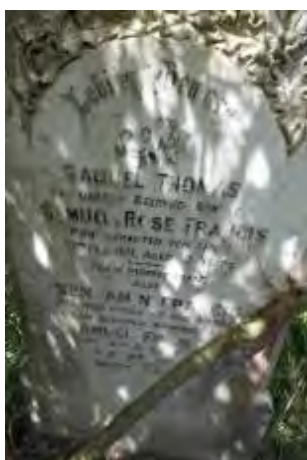
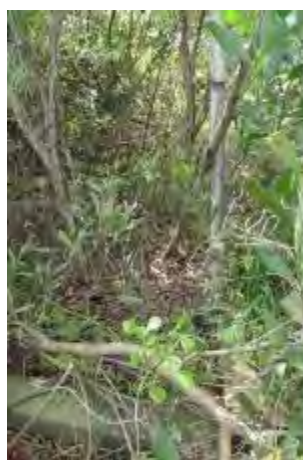
The third group, a single headstone with a double grave border dating from 1911, is in the far south-eastern portion, an area originally designated as Wesleyan. The grave is currently obscured by vegetation (Plate 9).

Plate 9 – Burial in Wesleyan section – far south easter portion of cemetery.

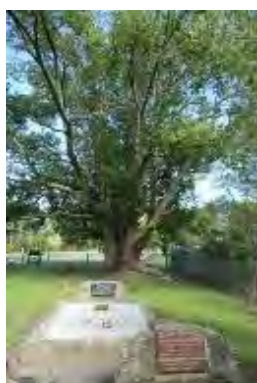
Analysis: The mature trees are an important feature of the cemetery, in particular the camphor laurel on the northern side of the entrance gate and the deodar cedar on the eastern boundary.

Camphor laurel

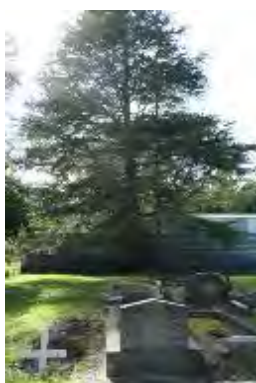
Deodar cedar

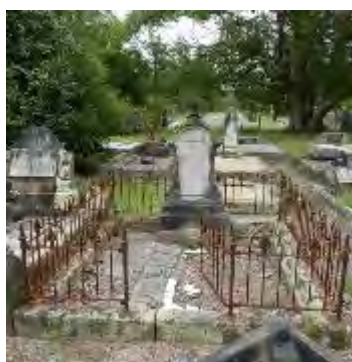
Analysis: The Johnston Family Cemetery has retained the appearance of a mid-twentieth century graveyard.

Late nineteenth century headstone & cast iron fencing

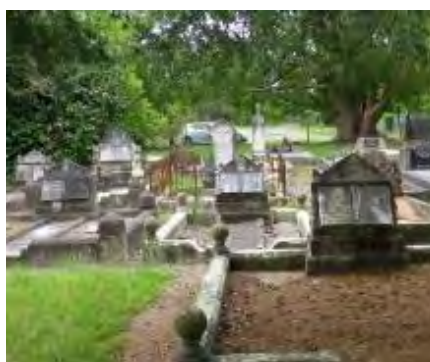
Note similarity in headstone and grave surround styles

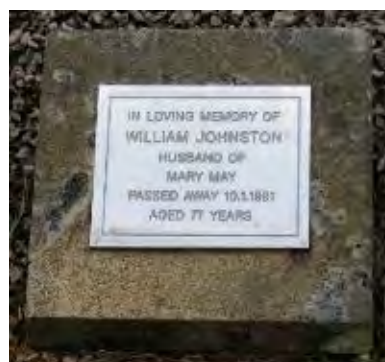
Small memorial plaque.

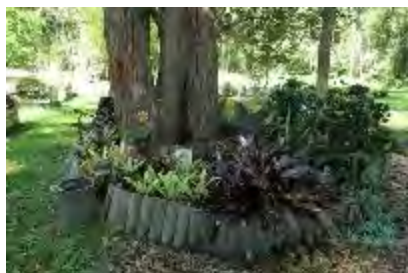
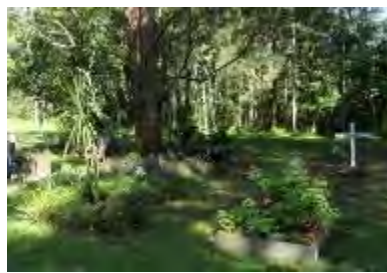
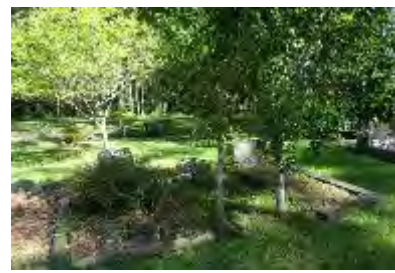
Analysis: The gardens have been established to memorialize those buried. The planting of some species in, or near graves, has the potential in the long term to impact on nearby headstones.

Example of small gardens established by relatives

The development of 'personal' gardens creates an issue with inappropriate plantings, such as large species on or adjacent graves. Over time, personal gardens may receive less attention and deteriorate resulting in a negative impact on the ambience of a cemetery.

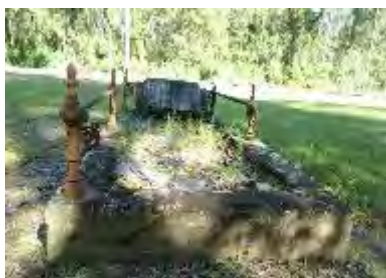
Analysis: Representative of the transition of headstone styles from the late nineteenth century to the present day. In terms of management, the earliest stele monument and cast-iron surrounds are most vulnerable to damage resulting from their age, style and type of material. That risk of damage decreases with the lower profile mid-late twentieth century headstones with the beam style, by nature, most resilient to damage.

Mid-late twentieth century headstone.

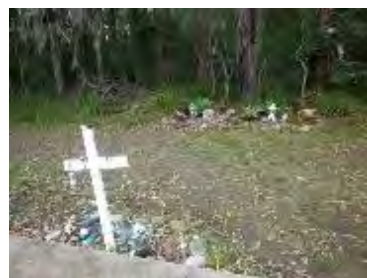
Late twentieth century beam headstone.

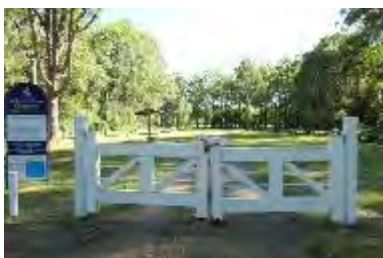
Analysis: The gates and fences are appropriate and adequate to the task.

Entrance gate

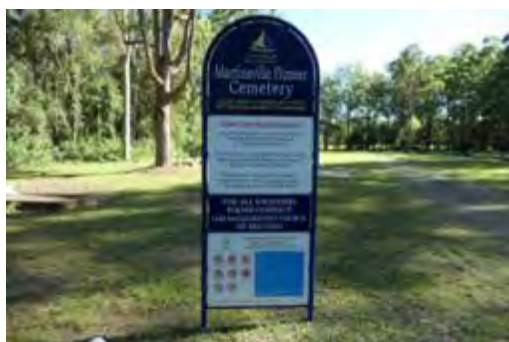
Analysis: The cemetery warrants a roadside sign to indicate its presence. At the cemetery, the Council sign, other than the location, is generic to all other cemetery signs. Given the historic nature of the cemetery, a sign with information such as: a plan of the cemetery layout, a brief history, information on graves of note is warranted.

Entrance sign

Element	Requirement	Priority	Recommendation
			Provide cemetery plan adjacent the front gate. Install a Martinsville Cemetery sign on the roadside to assist identification for drivers.
Heritage interpretation	Promotion as a source of historical and family information	Moderate	Develop and install accurate, informative, engaging heritage interpretation sign/s.
Environmental factors	Fire and storms	High	Maintenance plans to include removal of hazardous trees and undergrowth, grass regularly mown in high-risk seasons.
'Friends of'	Engage community groups	Moderate	Encourage groups to advance heritage research on interments. Assist in grounds and memorial maintenance working under the <i>National Trust (NSW). (2009) Guidelines for Cemetery Conservation</i> .

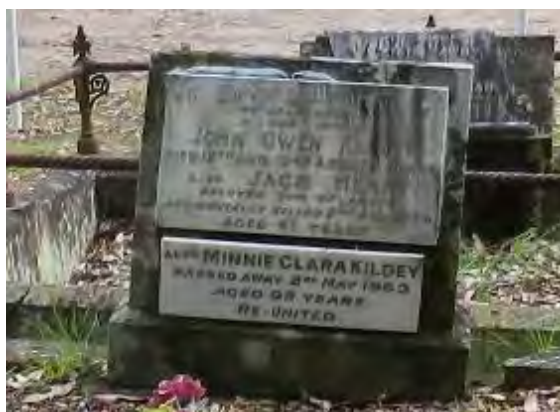
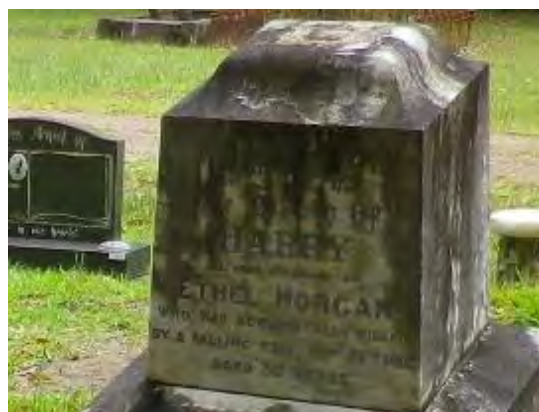
Figure 5 Inscriptions - accidental deaths

The early portion of the cemetery has several headstones that detail accidental death with a number specific to the timber industry. Those headstones are witness to an industry that held significant dangers for workers.

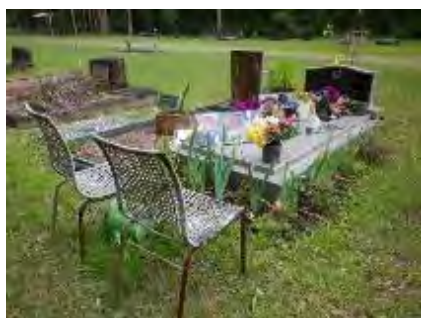
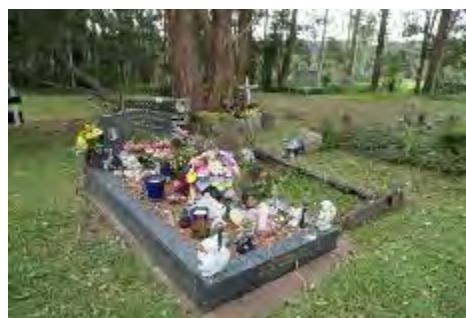
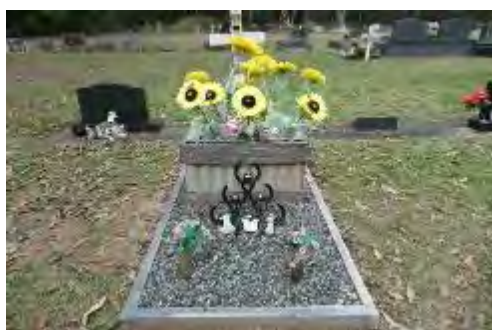
Figure 6 Examples of modern memorials

Martinsville Pioneer Cemetery has several personalised graves. Family members or friends have decorated the areas of the grave and in some instances, nearby areas with distinct memorials that reflect the life and interest of the person interred. These personalised tributes reflect a cemetery that retains close links to the local community.

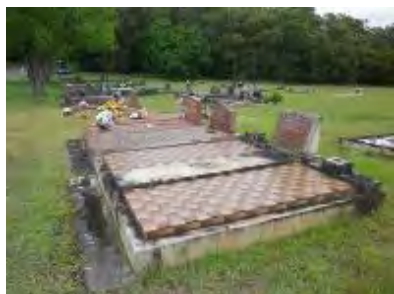
Analysis: The cemetery layout reflects a traditional arrangement, tempered by the need to ensure later burials do not impact on the numerous unmarked burials.

Traditional layout – graves facing east.

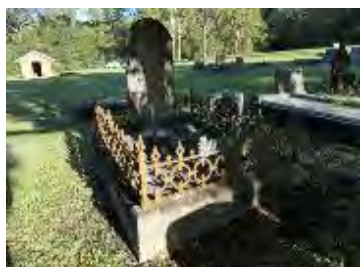
Analysis: Representative of the transition of headstone styles from the late nineteenth century to the present day. In terms of management, the earliest stele headstone and cast-iron surrounds are most vulnerable to damage resulting from their age, style and type of material. That risk of damage decreases with the lower profile mid-late twentieth century headstones with the later beam style, by nature, most resilient to damage.

Late nineteenth to early twentieth century headstone.

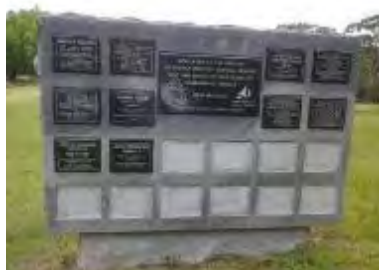
Analysis: The utilitarian style columbarium appropriately, is in the modern area. The memorial to the hospital patients is a positive step in recognizing their presence in the cemetery. It is unfortunate that the chapel has no information relating to its dedication.

Memorial Wall

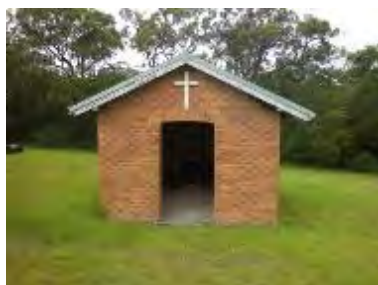
Description: Morisset Cemetery has a new columbarium that, at the time of survey, had not been used. A small chapel dedicated to the daughter of a local minister is present, however, there is no indication on the chapel of that dedication; the chapel has graffiti and mould inside. There is a Memorial Wall to the patients of Morisset Hospital.

Chapel

Element	Requirement	Priority	Recommendation
Chapel	Retention and utilisation	High	Make secure ;carry out remedial works to the interior; reinstate dedication; and consider possible future uses.
Gates and fences	Retention of gates and fences	Low	Regular maintenance.
Signage	Maintain existing signage and provide additional signage.	High	Install a cemetery plan sign. Provide additional denomination/ row # signage at end of each row as required.
Heritage interpretation	Promotion as a source of historical and family information	Moderate	Provide heritage interpretive sign/s for the Morisset Cemetery including its role as the burial place for Morisset Hospital patients.
Environmental factors	Fire and storms	High	Maintenance plans to include removal of hazardous trees and undergrowth, grass regularly mown in high-risk seasons.
'Friends of'	Engage community groups	Moderate	<p>Encourage groups to advance heritage research on interments.</p> <p>Continue to engage with the Morisset Hospital Historical Society in investigating methods of providing greater recognition for hospital patients interred at the cemetery.</p> <p>Assist in grounds and memorial maintenance working under <i>National Trust Guidelines for Cemetery Conservation</i>.</p>

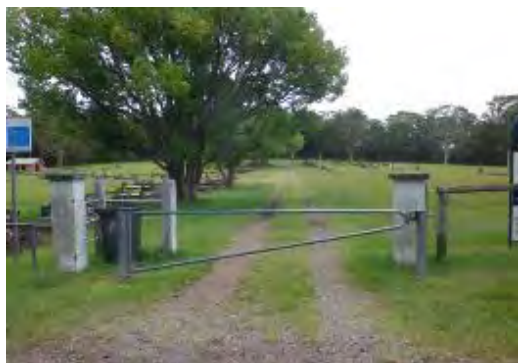
Description: Morisset Cemetery has a rudimentary steel entrance gate flanked by brick pillars. The gate remains locked unless access is required for interments. The fence on the east and western side is of treated pine and wire.

Analysis: The gates and fences appear adequate to their task and reflect the rural nature of the cemetery.

Entrance gate

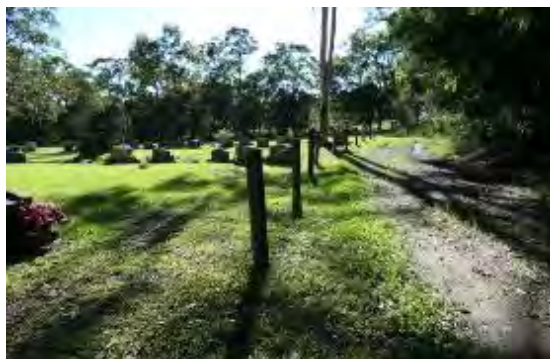
Western side fence

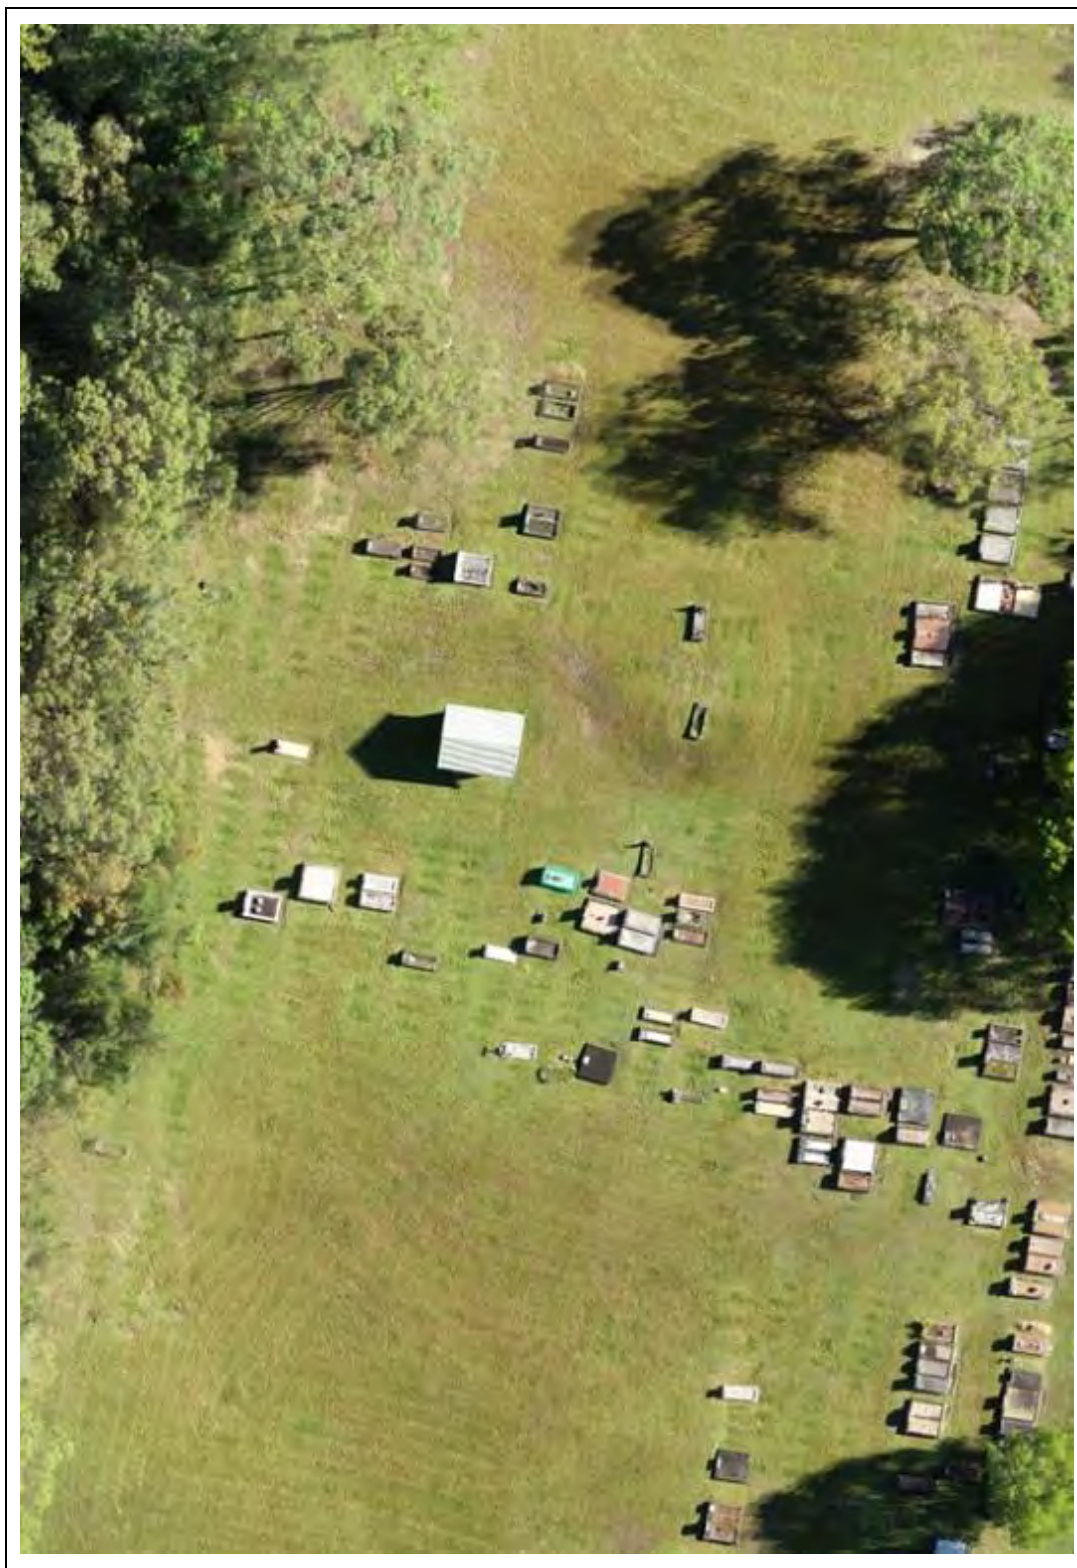
Figure 4 Morisset Cemetery portion - dark green indicates unmarked burials (RPS 2021)

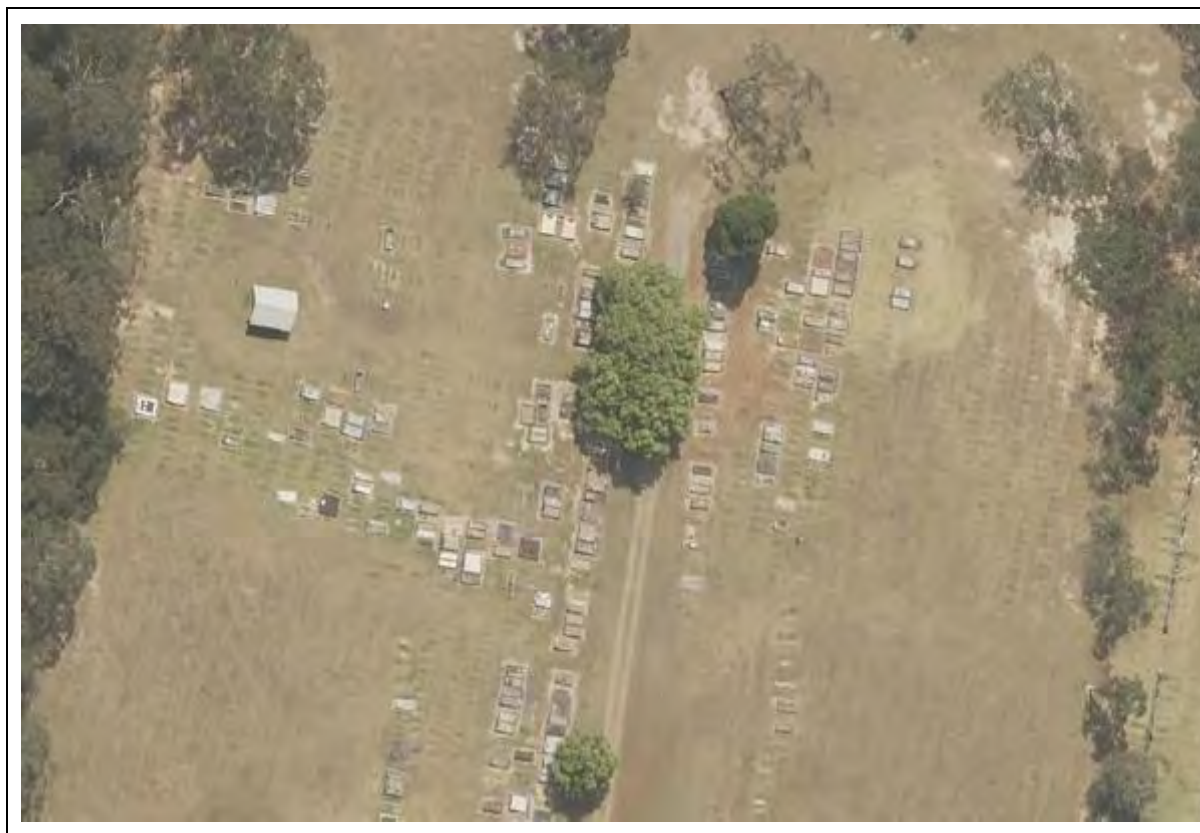
Figure 5 Morisset Cemetery – small dark brown patches of parallel lines indicate unmarked burials (LMCC date unknown)

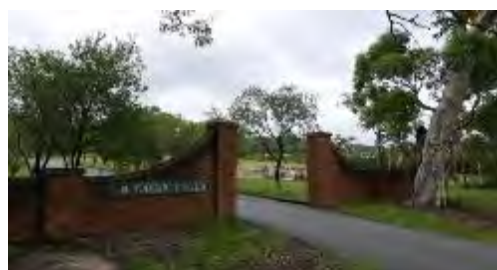
Analysis: The expansive area of the cemetery and distances between the various sections create a less than welcoming space. The views west to industrial estate likewise detract from the cemetery's appearance.

Entrance gates

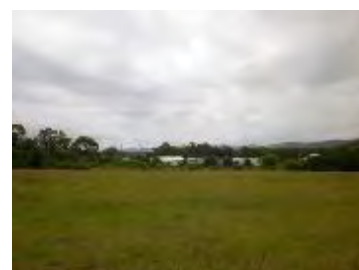
View west to industrial area

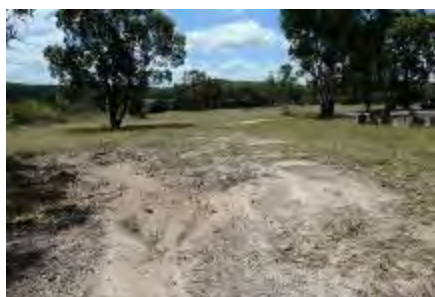
Analysis: The entrance driveway is particularly attractive, however, the large expanses of grass, unbroken by trees or shrubs detracts from the overall appearance.

Eroded areas south eastern section

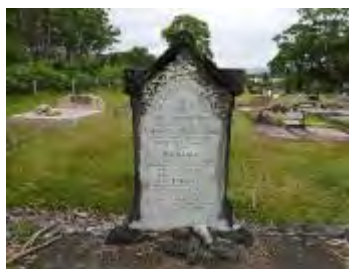
Analysis: Representative of the transition of headstone styles from the late nineteenth century to the present day. In terms of management, the earliest stele headstone and cast-iron surrounds are most vulnerable to damage resulting from their age, style and type of material. That risk of damage decreases with the lower profile mid-late twentieth century headstones with the beam style, by nature, most resilient to damage.

Late nineteenth to early twentieth century headstone.

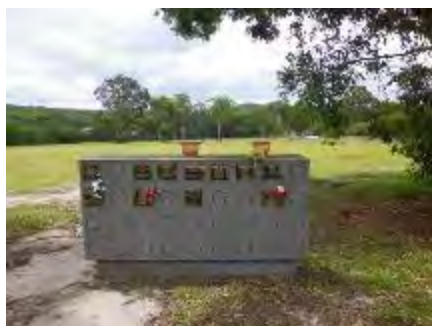
Analysis: The columbarium has been introduced to the cemetery since 2000. The style is utilitarian and in a relatively isolated section of the cemetery. Standing on bare ground it lacks the personalised gardens noted at other cemeteries.

Columbarium

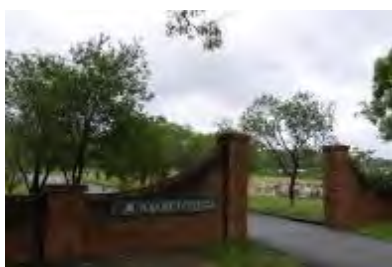
Analysis: The gates and fencing do not provide adequate security; this is evident in the vehicle tracks across graves. The entrance gateway, of red brick, is unattractive. It is noted that Whitebridge Cemetery has the same style of brick gateway which, painted white, presents a more pleasing appearance

Entrance gate

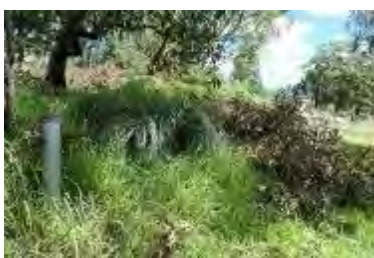
Southern fence

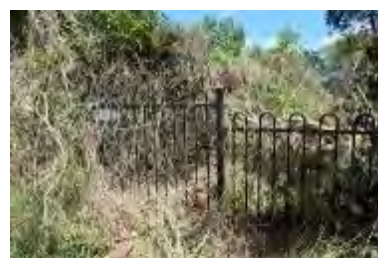
Western overgrown fence

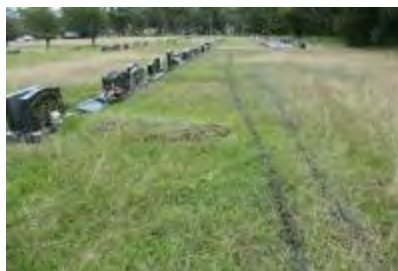
Vehicle tracks over graves.

Analysis: Further consideration should be given to limiting unwanted vehicle access.

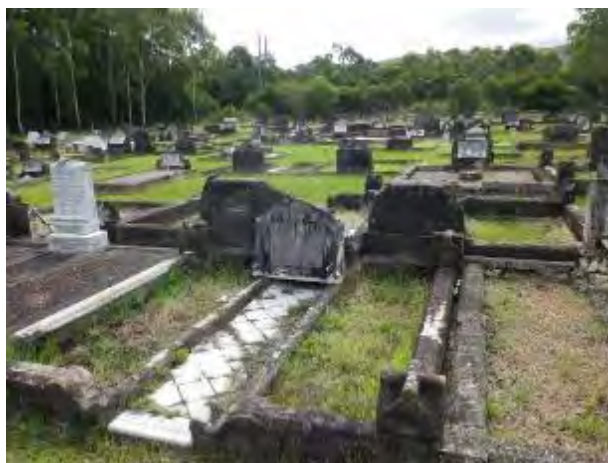
Analysis: The cemetery's grid layout is consistent with other cemeteries however there is no readily apparent division by denomination.

Grid layout

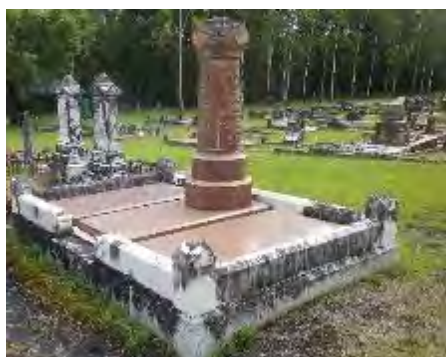
Analysis: The early headstones and cemetery surrounds at West Wallsend are distinct and different from the other cemeteries investigated. That distinct style is representative of the boom years of the coal industry, with more modest memorials marking the decline of the industry and the change in monument style in the twentieth century.

Red granite with marble grave surround

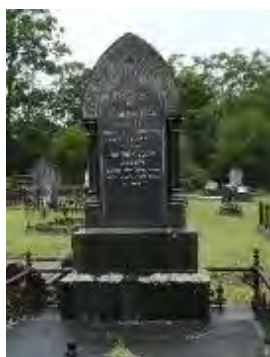
Black gabbro (granite)

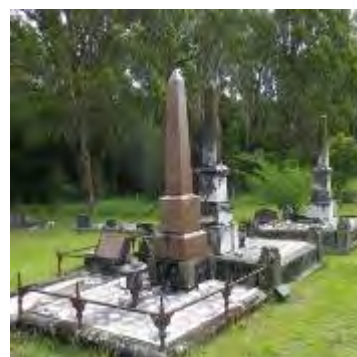
Granite and marble headstones

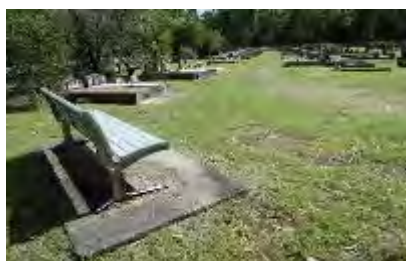
Analysis: Structures provided are adequate. Drainage provides a significant issue causing damage to grave surrounds through collapse of soft ground and erosion in addition to limiting access to the western portion of the cemetery.

Seating

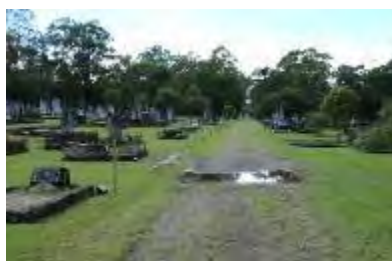
Drainage is poor. The cemetery is on a low slope leading to a wetland area in the south. During periods of rain run-off causes erosion and boggy ground around graves, while on the sole internal access track, water pools.

Water on internal access track

Element	Requirement	Priority	Recommendation
			grass regularly mown in high-risk seasons. Install appropriate measures to manage drainage.
'Friends of'	Engage community groups	Moderate	Encourage groups to advance heritage research on interments. Liaise with the West Wallsend Cemetery Committee. Assist in grounds and memorial maintenance working under <i>National Trust Guidelines for Cemetery Conservation</i> .

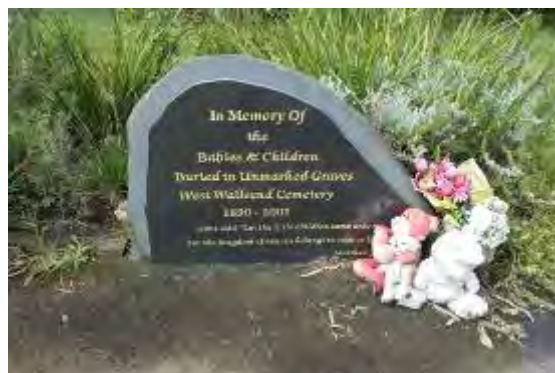
3.3.2 *Memorial to babies*

In discussion with Anne Andrews, it was found that babies and children were sometimes placed in now unmarked graves on the southern side of the cemetery. In recognition, the West Wallsend Cemetery Sub-Committee in 2002, placed this inscribed boulder in their memory.

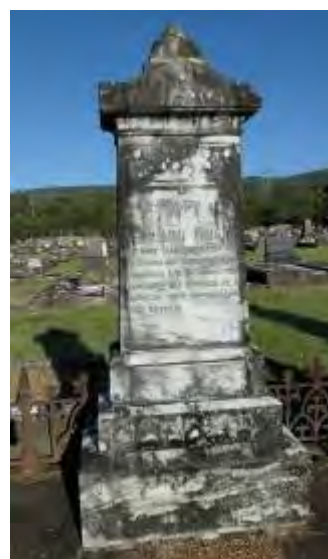
3.3.3 *Memorial to Archibald Fairley*

West Wallsend is the only cemetery under the management of LMCC to have a memorial erected to an individual, Archibald Fairley. The monument sits beside the family's memorial on the grave site. The inscription reads

'In memory of Archibald Fairley, for many years Superintendent of Seaham and Abermain Colliery Companies Ltd by whom this monument was erected as a mark of their appreciation and esteem'.

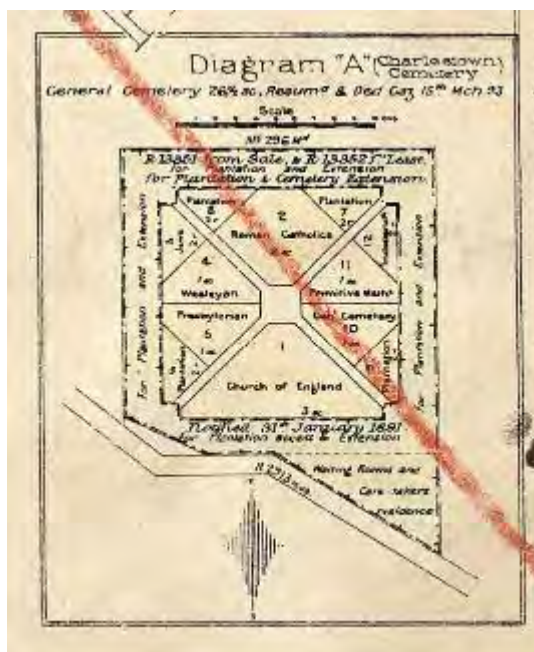
Figure 6 Extract: County of Northumberland. Parish of Kahibah 6th Edition. 1905 (NSW Land Registry Service)

The cemetery received a boost in 1893, with a Works Department grant of £112 for clearing and fencing (1893 'TELEGRAMS.'). The cemetery's design, roughly fashioned on a Maltese Cross appeared as an English formal garden with graves located in circles and semi-circles dotted around the cemetery (Figure 6). This was a departure from the normal simple, square cemetery layout.

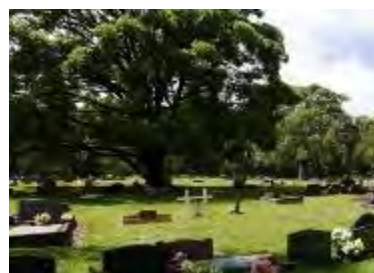
Circular graves with tree centre

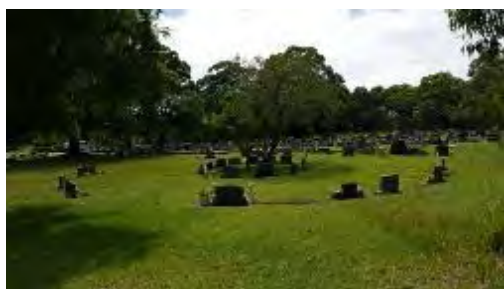
Analysis: The cemetery's unusual layout is not consistent with other LMCC cemeteries.

Circular layout

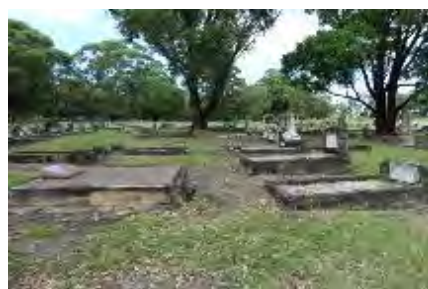
Traditional layout

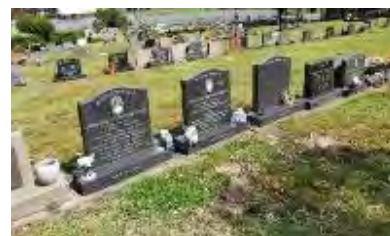
Analysis: Representative of the transition of headstone styles from the late nineteenth century to the present day. In terms of management, the earliest stele headstones and cast-iron surrounds are most vulnerable to damage resulting from their age, style and type of material. That risk of damage decreases with the lower profile mid-late twentieth century headstones with the beam style headstone by nature most resilient to damage.

Late twentieth century beam headstones.
