Cemeteries Conservation Management Plan

VOLUME 2 – INDIVIDUAL CEMETERIES

SEPTEMBER 2021

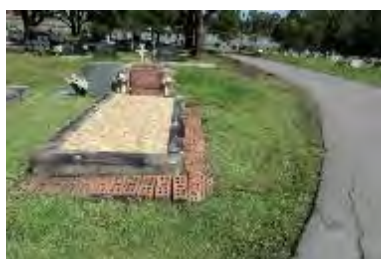
Damage to grave by vehicles

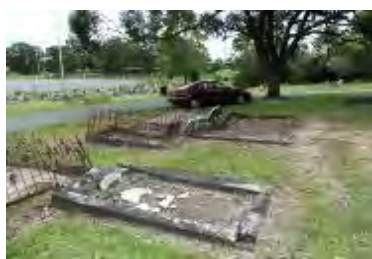
Car parked on area of potential unmarked grave

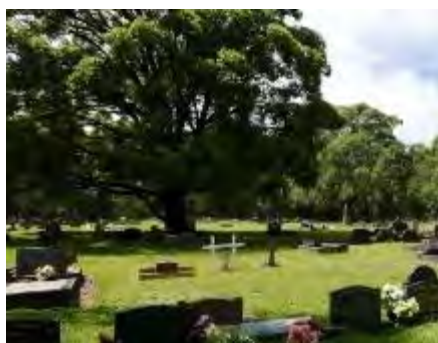
Figure 8 Whitebridge cemetery layout

The cemetery's original ornate layout has disappeared. In 1981, the adoption of graves in circular and semi-circular pattern was a marked departure from a grid layout. The cemetery plan was further impacted by the development of netball courts, which have resulted in the further alienation of the Presbyterian portion.

Circular layout

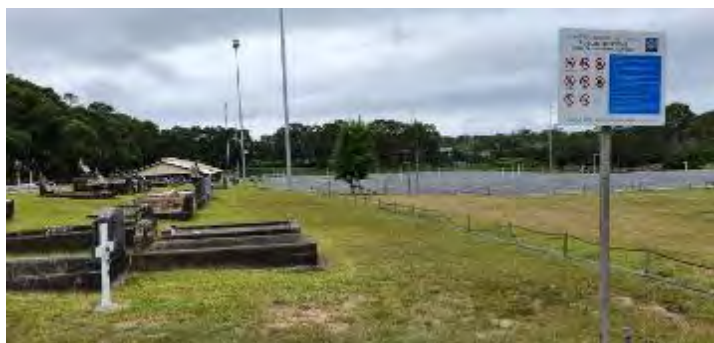
Presbyterian section adjoining netball courts

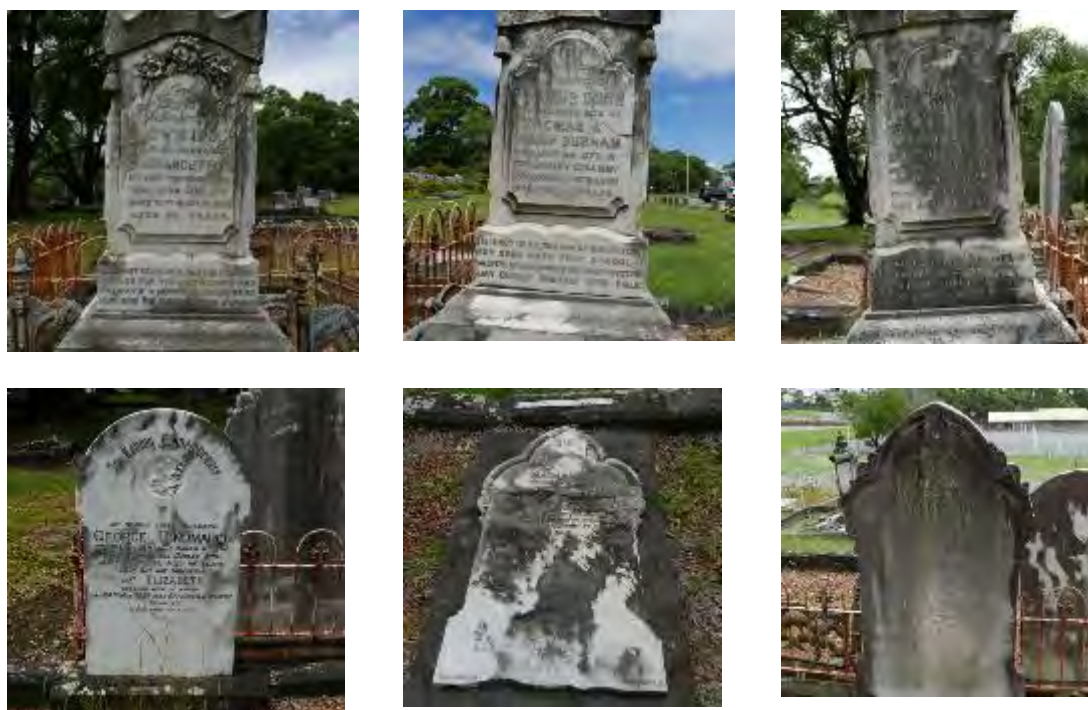
The Dudley Colliery disaster in 1898, caused the death of fifteen men. The explosion, resulted when gas lamps lit at the start of the shift, ignited gases and coal dust destroying underground workings and surface infrastructure. The majority of the fifteen men were buried at Whitebridge Cemetery (Lake Macquarie - Dudley Mine Disaster)

Figure 9 Headstones of several Dudley Mine Disaster victims (Heritage Archaeology and Planning)

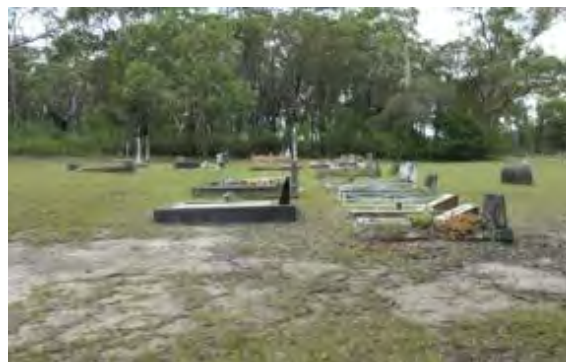
Analysis: The large central garden is complimentary to the cemetery; however, the large areas of bare and eroding ground surface give the cemetery an unkempt appearance.

Exposed ground surface

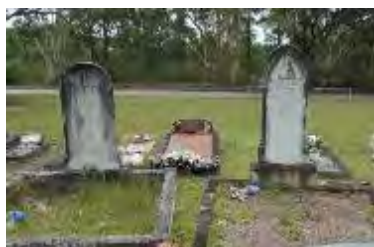
Analysis: Representative of the transition of headstones styles from the late nineteenth century to the present day. Many of the headstones are covered with black mould which makes reading inscriptions difficult. In terms of management, the earliest stele headstones and cast-iron surrounds are most vulnerable to damage resulting from their age, style and type of material. That risk of damage decreases with the lower profile mid-late twentieth century headstones with the beam style headstones by nature, most resilient to damage.

Late nineteenth and early twentieth century headstones.

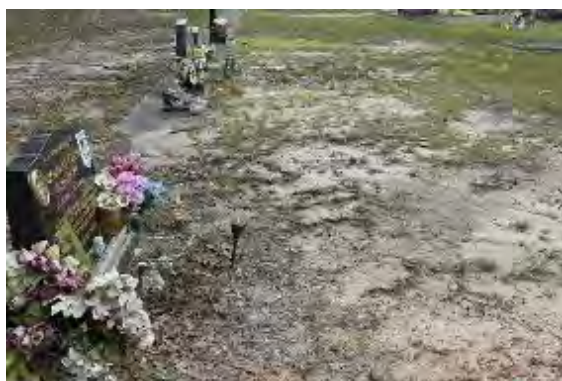
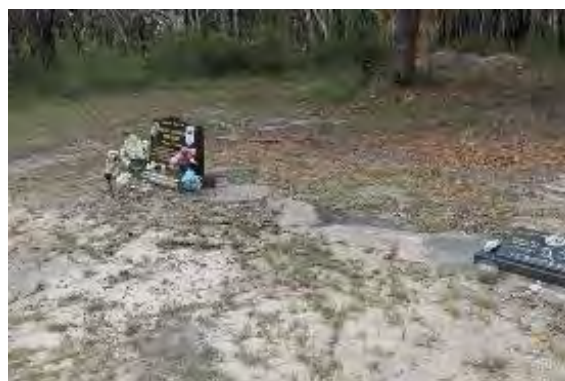
Description: Wyee Cemetery has no other structures. Drainage is an issue; north flowing run-off is having a negative impact on several beam graves in that area of the cemetery.

Analysis: A simple small cemetery, other than seating it probably does not require further infrastructure. Poor drainage is having a significant impact and warrants remediation.

Graves at the northern end of the cemetery – impact of poor drainage and erosion
